**CANADIAN FORCES
FLIGHT SAFETY INVESTIGATION REPORT (FSIR)**

FINAL REPORT

FILE NUMBER: 1010-N261 WL (DFS 2-3-2)
DATE OF REPORT: 1 April 2005

AIRCRAFT TYPE: A4N Skyhawk
OCCURRENCE DATE/TIME: 161830Z June 2004
LOCATION: Bagotville, Québec
CATEGORY: "D" Category Incident

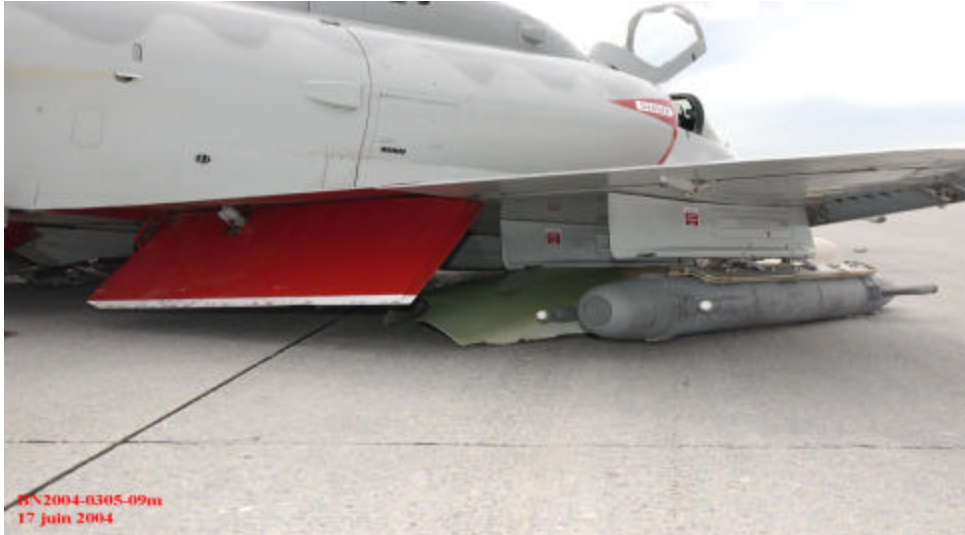
The aircraft suffered “D” category damage. Damage was limited to the external fuel tanks, left hand wing flap, nose panels, and some damage to a jamming pod which the aircraft was carrying. The external fuel tanks were sliced open when the aircraft skidded over the arrestor cable.

The aircraft, except for external tanks, retained its integrity throughout the landing slide (photo 1). Debris from the external tanks was scattered around the area just past the arrestor cable (photo 4). The bottom half of the left external tank remained engaged in the cable.

Photo 1: Tank and pod damage

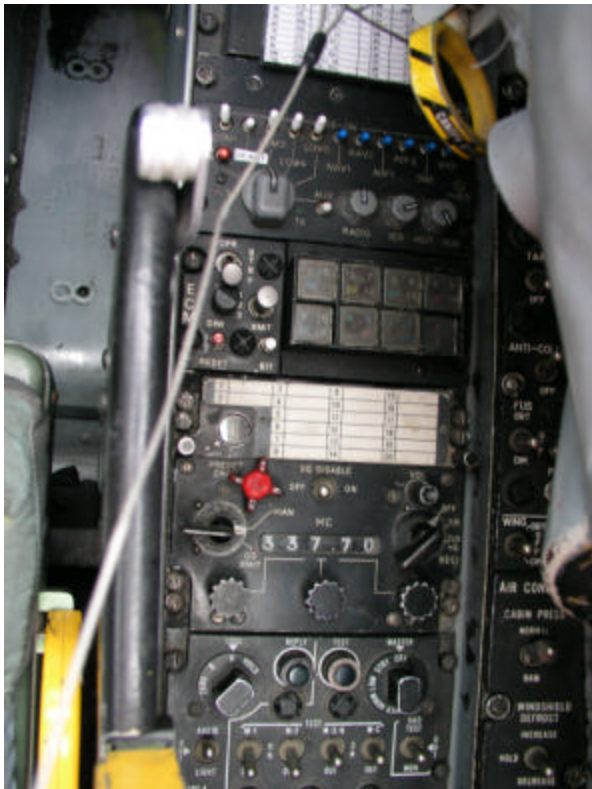
The aircraft has three radios consisting of 2 UHF radios and 1 VHF radio. Both UHF radios, an AN/ARC-151/9 and an AN/ARC-51A are located on the right console (photo 2). The single VHF radio is part of the Garmin 530 Navigation package and is located on the front instrument panel. The NAT 301/A Audio Control Panel controls radio selection. This panel is capable of monitoring and communicating on five transmitters and monitoring six additional frequencies and is located on the upper right console of the A4N.

The small rotary radio selector switch located underneath the pilot's right arm was in the VHF position (inter-plane) instead of the UHF (Tower) position when the aircraft entered the break. The pilot responded on the wrong radio and quickly realized it. Correction of the switch position required the pilot to switch control hands, move the switch and respond to Tower's second call. This interrupted the pilot's landing checks, and he did not lower the landing gear.

Photo 2: Right Console

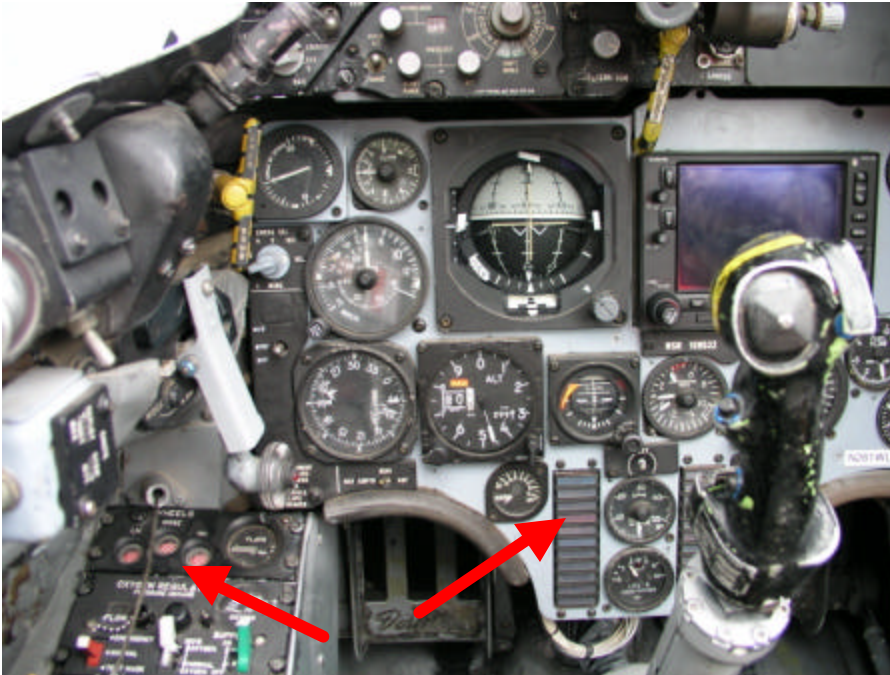
The aircraft uses a tricycle landing gear system. The landing gear is retracted and extended by utility hydraulic system pressure during normal operation. The main gear retracts up and forward and the wheels rotate to fit flush in the wheel wells in the wings. The nose gear also retracts up and forward. The landing gear handle is located forward of the left cockpit rail and controls normal operation of the landing gear system. The handle has two positions "UP" and "DOWN" and is mechanically linked to the landing gear control valve. The position of the wheels is shown on a combination wheel and flap position indicator located on the lower left hand console (photo 3).

The A4N is a small aircraft with a small cockpit and is an older design. With some integrated modern technology, the instrumentation for flying and fighting is placed in prime areas while other items like the landing gear handle, gear down and locked indicators, and radio transmit selector are placed where they can fit in. The gear handle and indicators are small and located down low on the left hand side of the instrument panel. The radio rotary selector switch is small and located on the NAT 301/A Audio Control Panel on the console underneath the pilot's right arm beside the canopy jettison handle. The steady red light in the gear handle is dim in daylight and the flashing "WHEELS" annunciator can be blocked from view by the flight control stick.

Photo 3: Landing Gear & Annunciator Panel

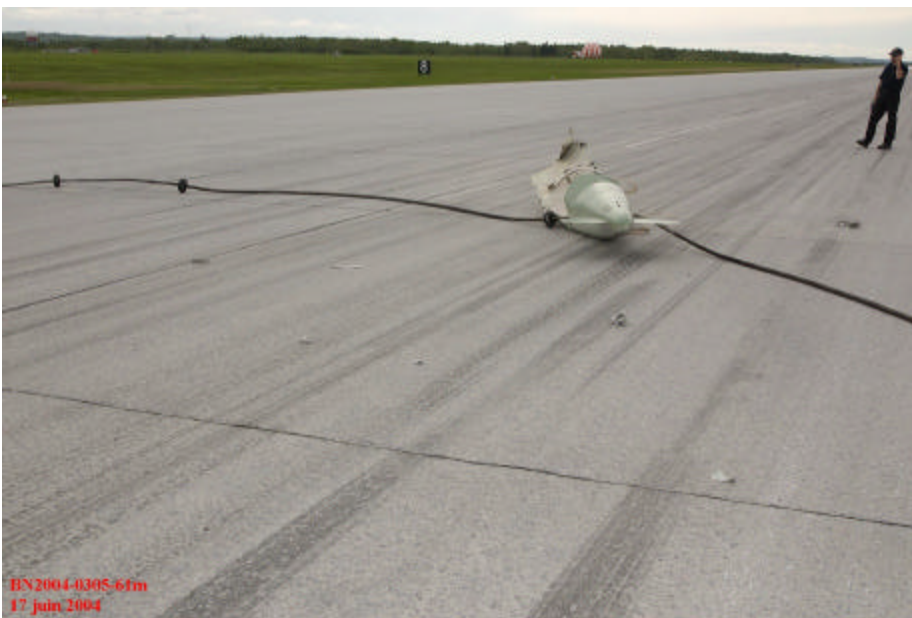
Photo 4: Left External Tank
